RAMMED EARTH

BIØN II- Follow-up report

By miga / ACTYVA

Written and edited by Lucile Couvreur, 2021

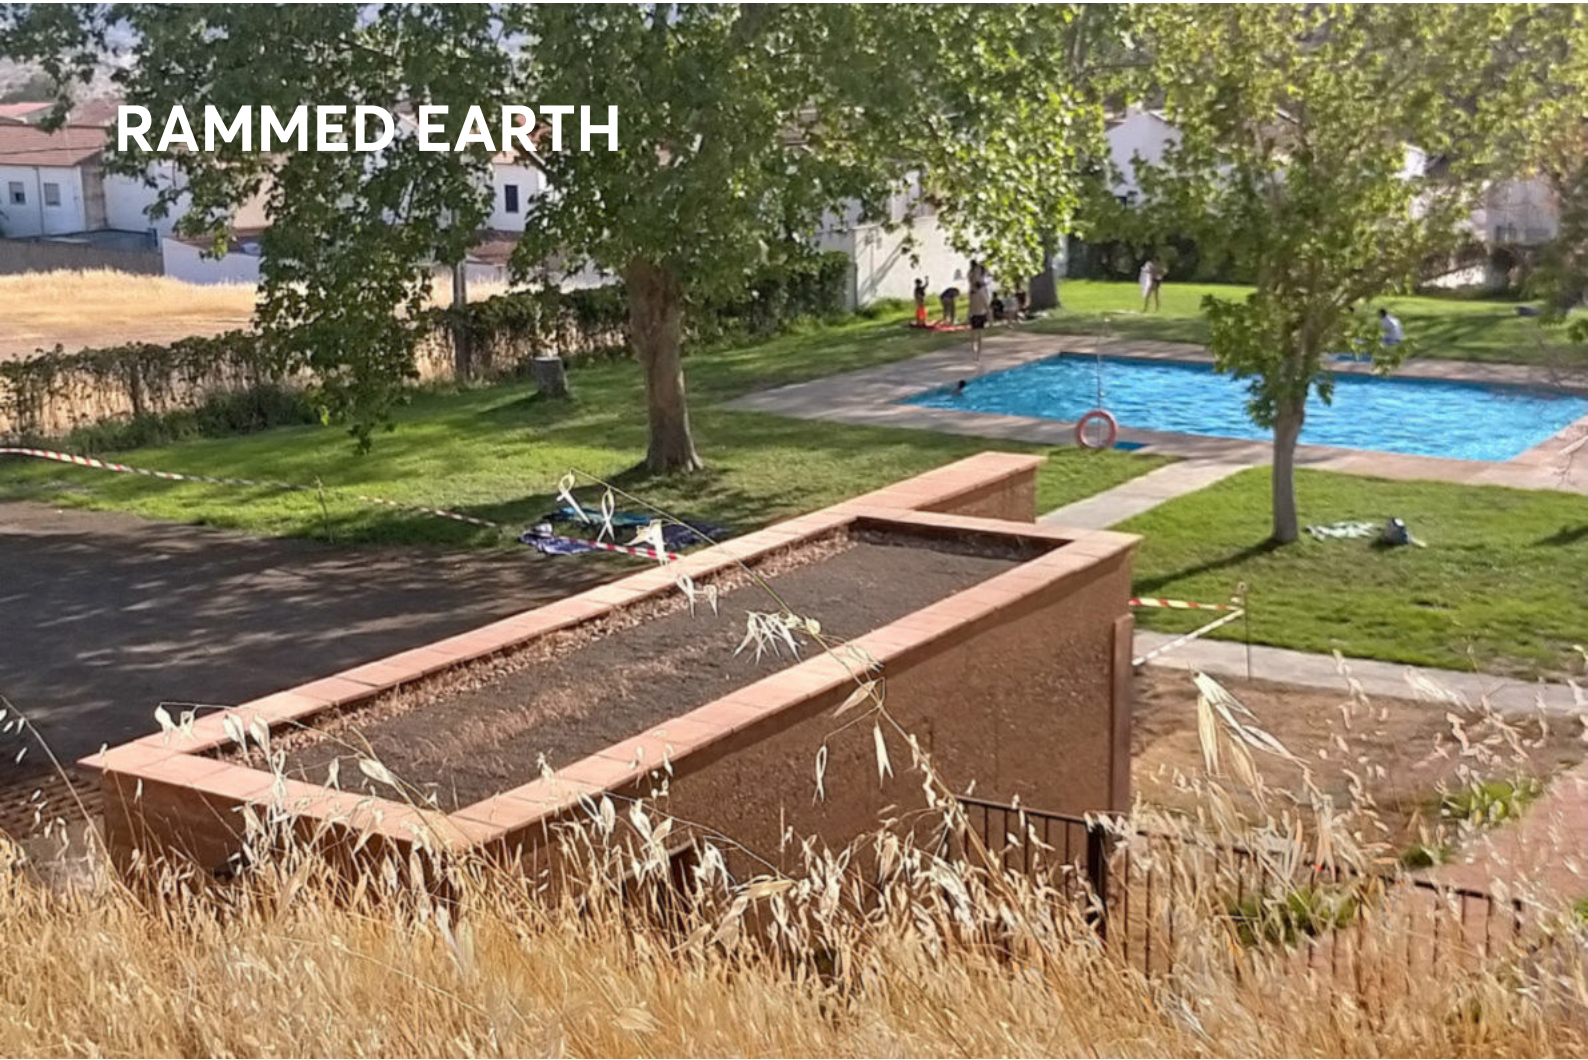
1. View on the library from the top, in the park of the municipal swimming pool (2021).

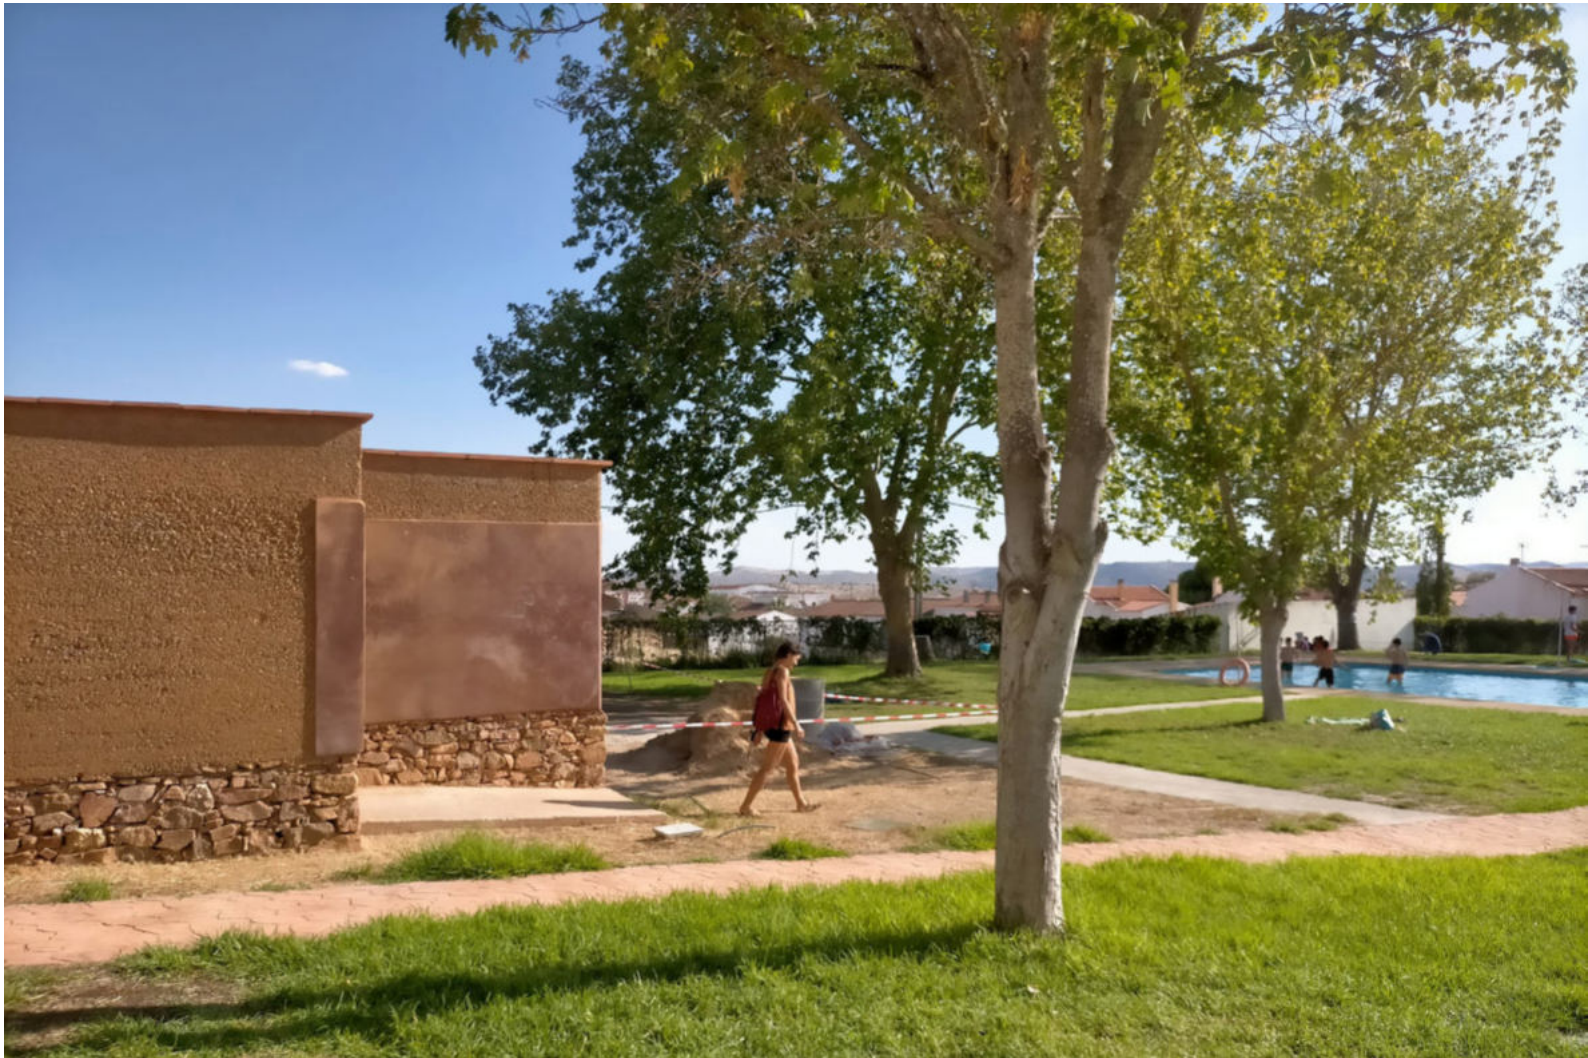
1. North facade of the library and access connecting to the park (2021).

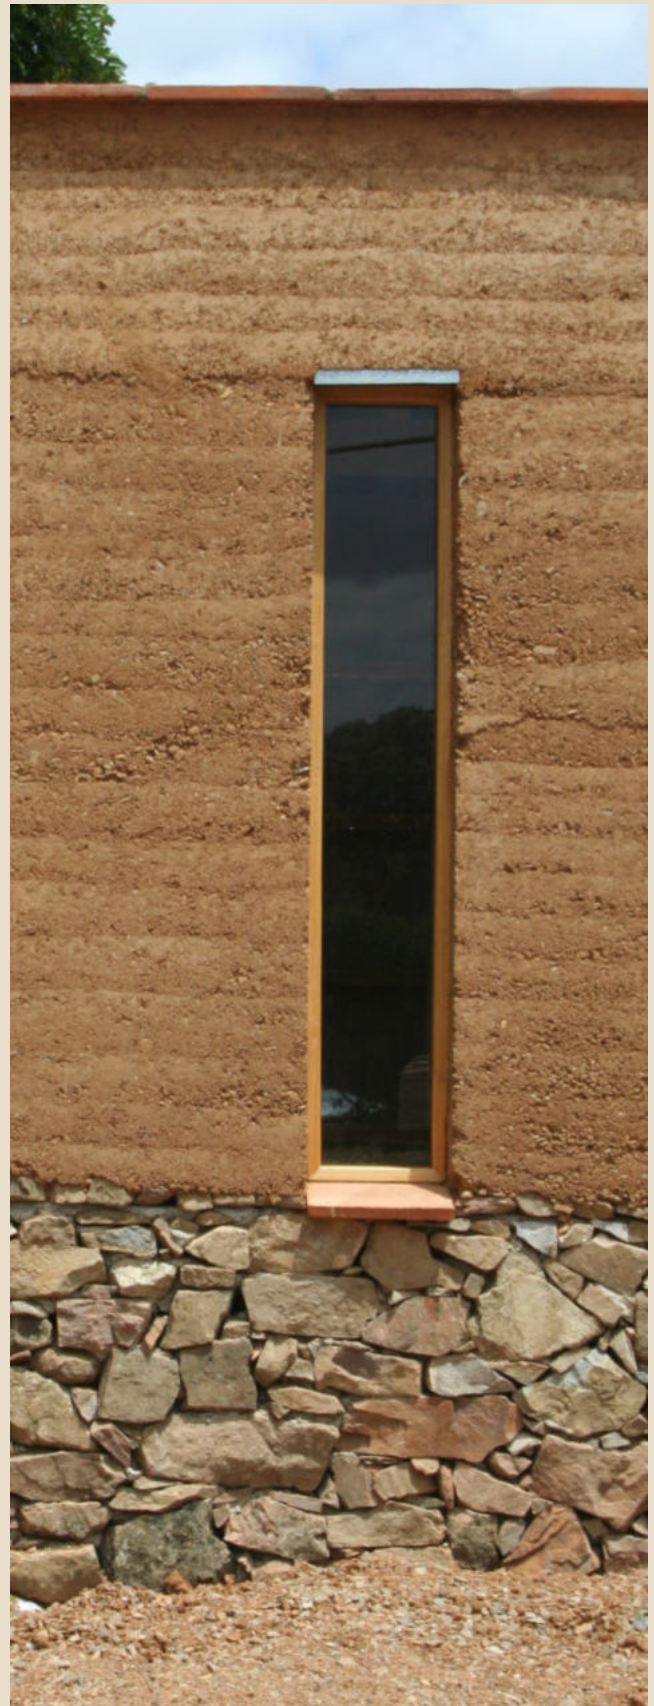
Where the materials came from ?

FROM SITE ¹ 86%

LOCALLY ² 10%

TRANSPORTED ³ 4%

Percentages of the total volume of materials.

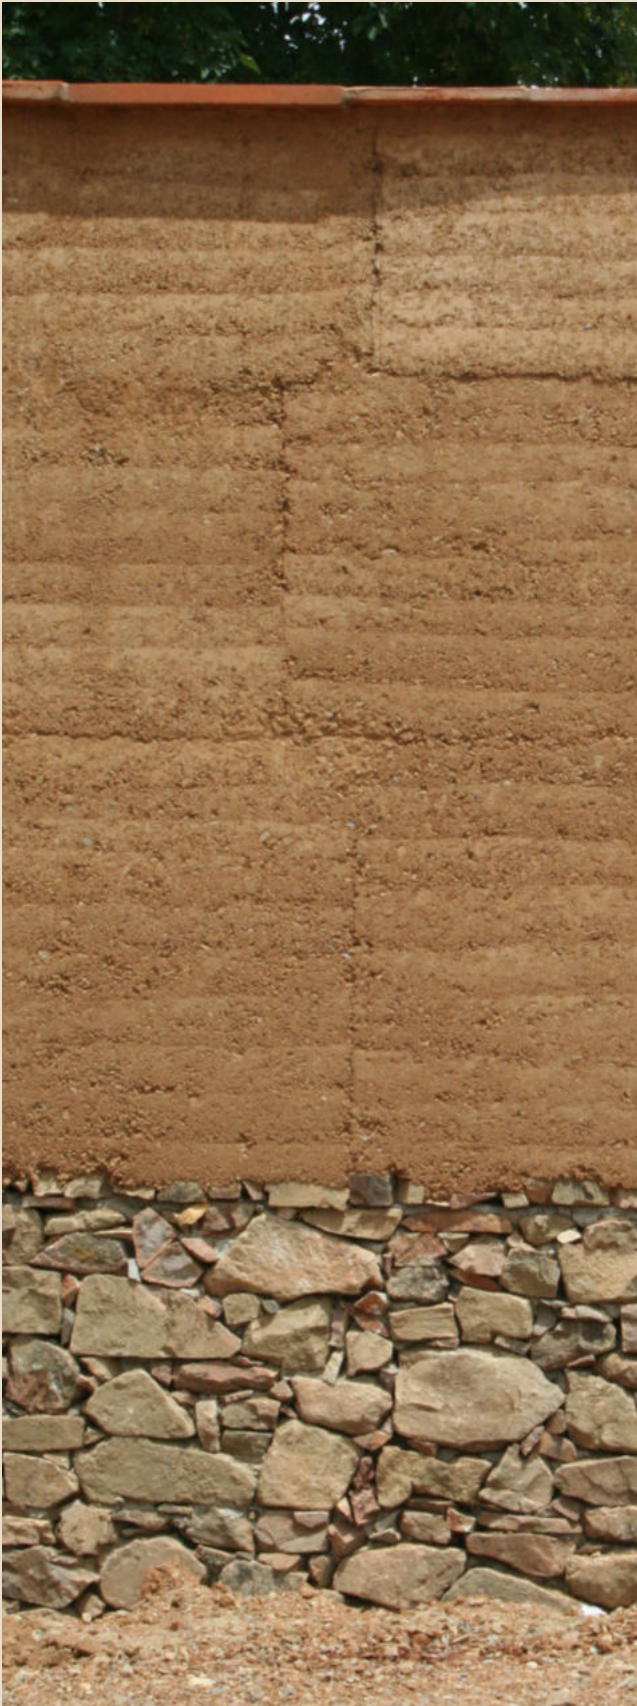
Type of material

EARTH 44%

Local earth mixed with coarse sand is the only component of the walls. It was compacted layer by layer at a humid state in wooden formworks before being sun-dried.

OTHER 29%

The rest of the material is cement mortar (foundations), lime mortar (slab and plasters), wood (roof, ringbeam, windows and door), metal (screws, nails, etc.), plastic (roof membranes) and ceramic (parapet and windows tiles).

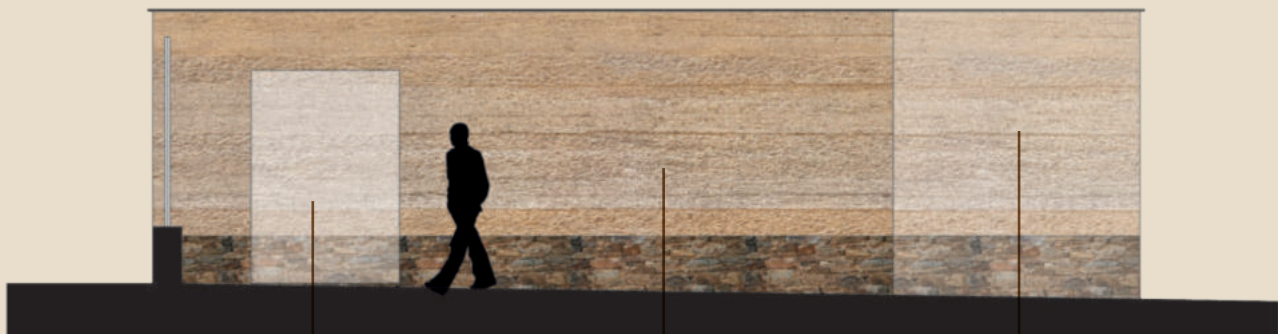
NORTHERN FACADE

A

Natural ageing of the wooden part of the doors + incomplete air tightness.

B

Natural erosion of the rammed earth walls.

C

Heterogeneous aspect of the lime plaster.

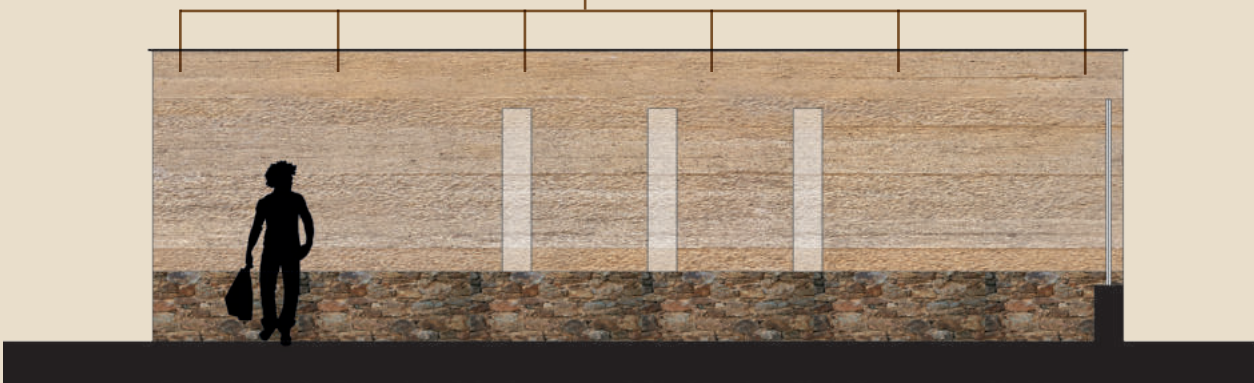
SOUTHERN FACADE

D

Slight erosion due to water surface runoff inbetween the parapet tiles.

On this last aspect (the roof), there is a slight default on the building that could be corrected which is the small gaps that are starting to appear inbetween the ceramic tiles of the parapet

due to the wear of the cement joints. Therefore, small quantities of water are running inbetween the tiles and causing a slight erosion on the top of the wall. This is a phenomenon quite invisible for now but that could accentuate if no maintenance of the building is made. Actually, on the northern and southern facade is almost imperceptible for the moment, but on the western facade, a small cavity in the rammed earth already appeared.

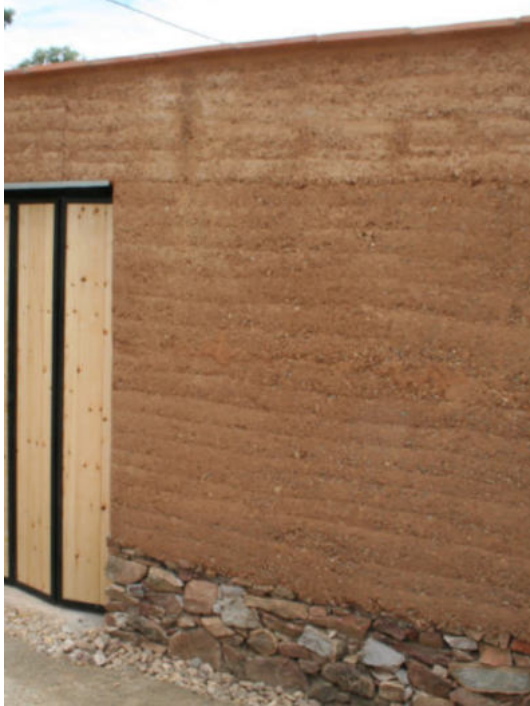
This page
1. Detail of the northern facade in 2018.

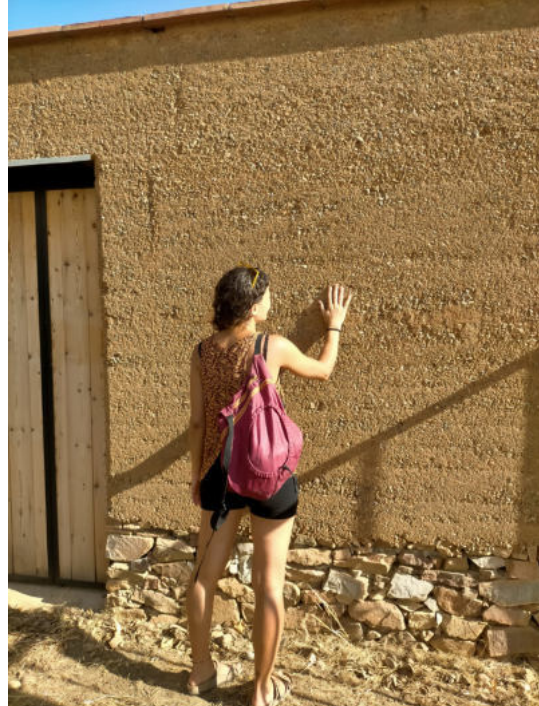
While inside the building the walls remain unchanged since their construction, the exterior walls clearly suffered an erosion process due to weathering exposition. As it could be predicted, the finest particles composing the mix (fine sands, silts and clay) were "washed", making the biggest particles (coarse sands, gravels and stones) more visible on the surface.

This natural erosion process is also called "controlled erosion process" and must not be perceived as a pathology of a building, but just as an aesthetic variation. In the first years of life of the building, this phenomenon is especially pronounced, and then slowly disappears, when all the small particles have been washed away (this is one of the reasons why it's important to have big particles in the rammed earth mix: they provide a long term surface weather resistance). Therefore, loss of mass resulting from this erosion process is so small compared to the thickness of the wall that it can't affect the structural stability of the building. This phenomenon has been largely studied and documented by Martin Rauch, an Austrian builder who has used for years the unstabilized (no cement) rammed earth technique.

2. Same detail in 2021.

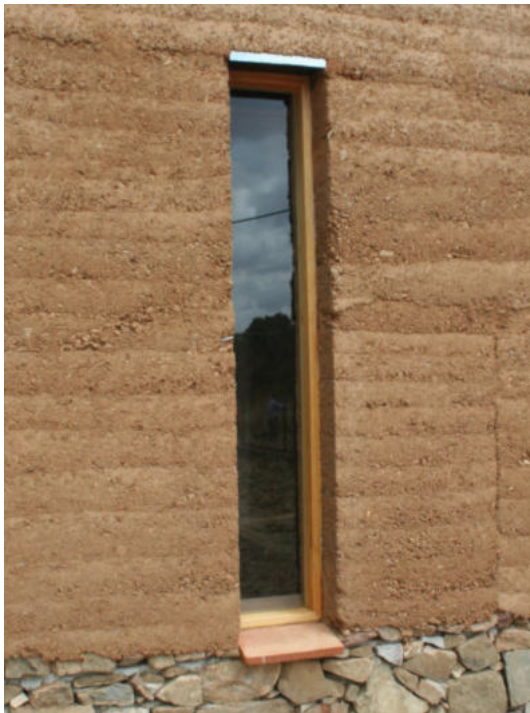
3. Detail of the southern facade in 2018.

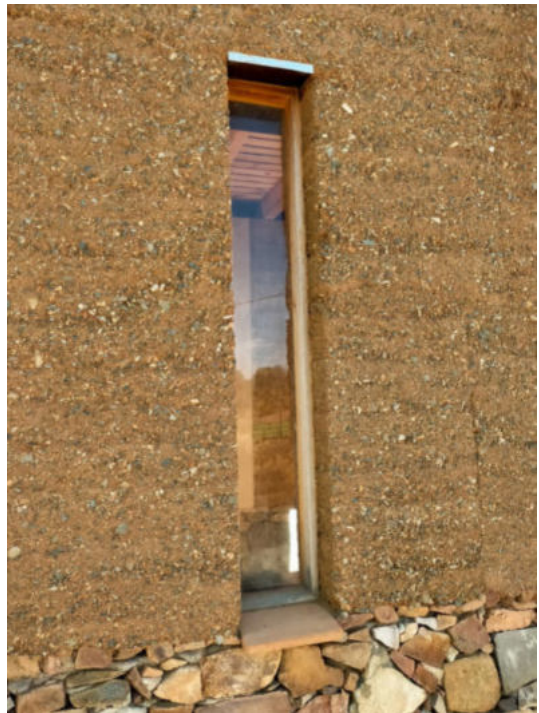
4. Same detail in 2021.

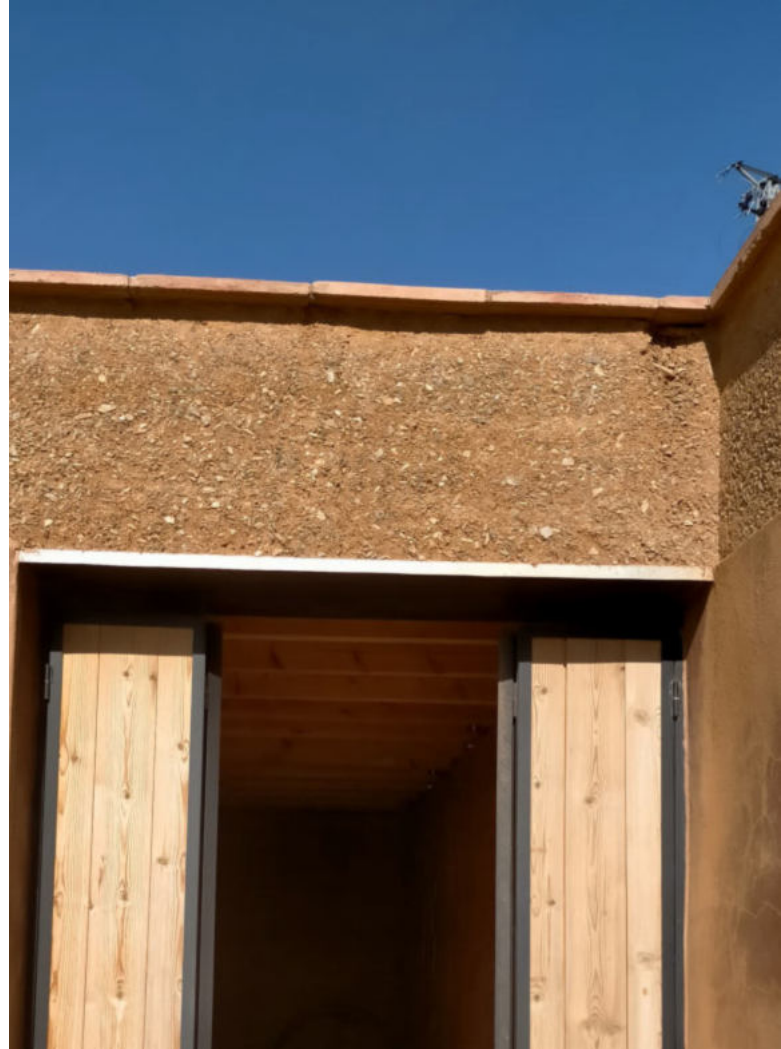
1. Detail of the top part of the door on west facade in 2018. A slight crack appeared in the rammed earth in the drying phase.

2. Same detail in 2021. A small cavity appeared in the rammed earth in the corner due to water flowing inbetween the tiles.

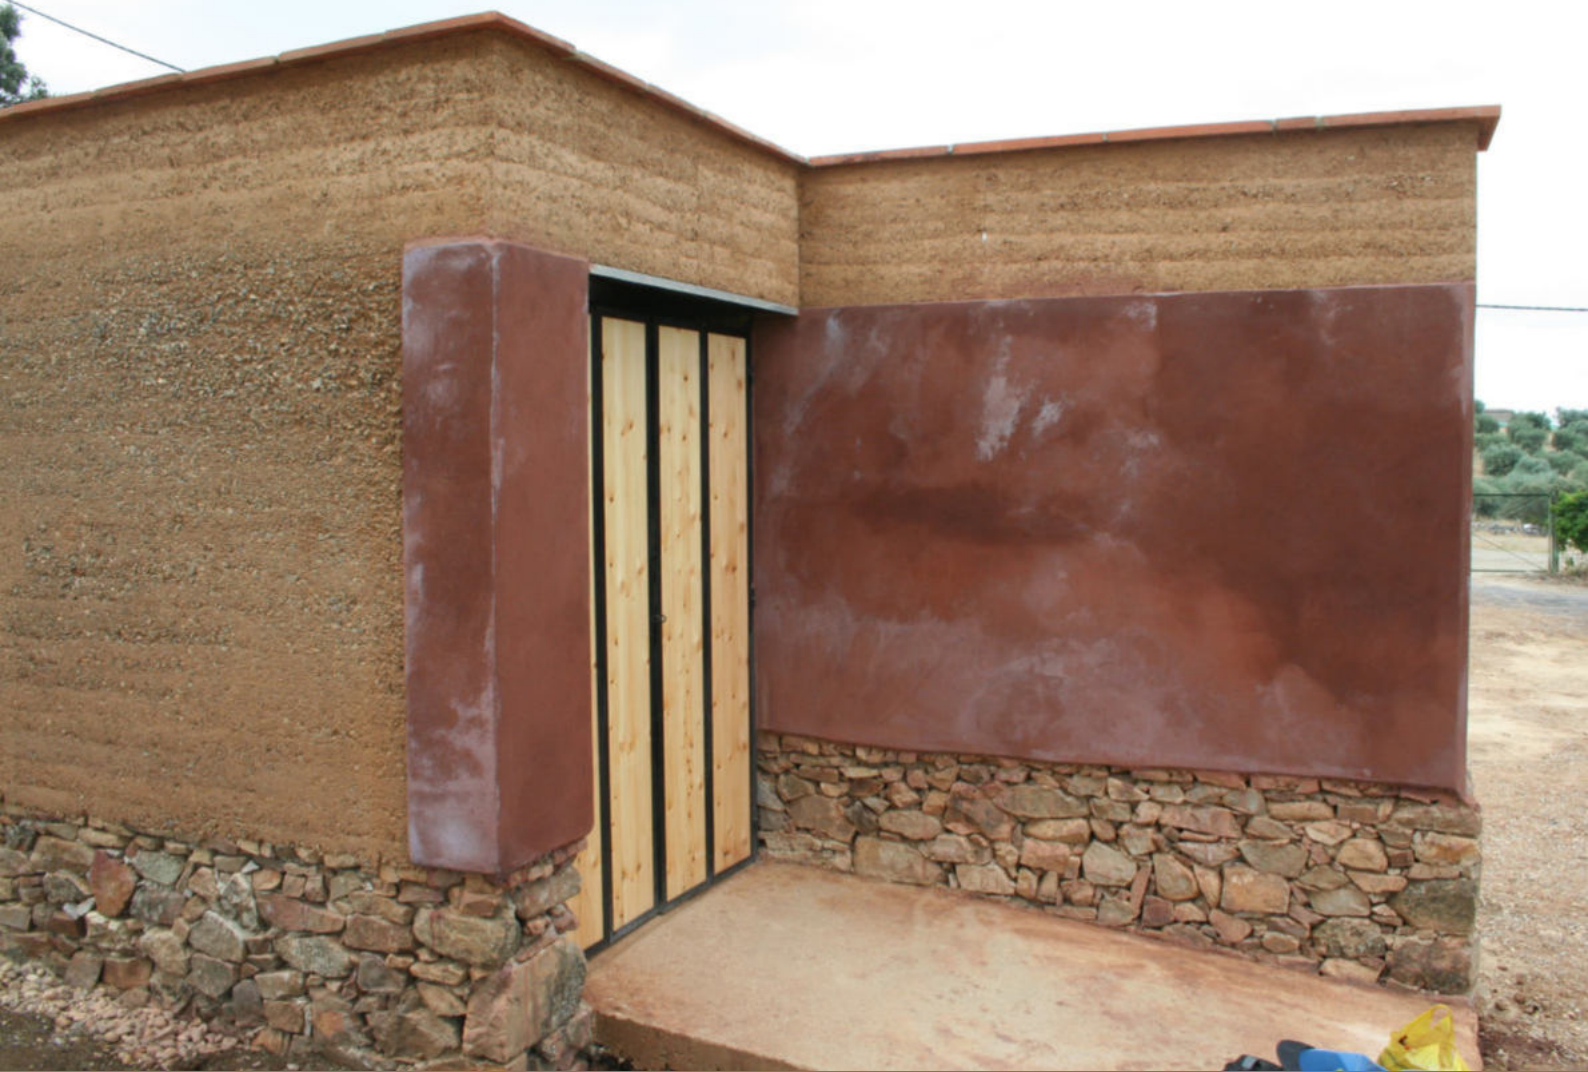
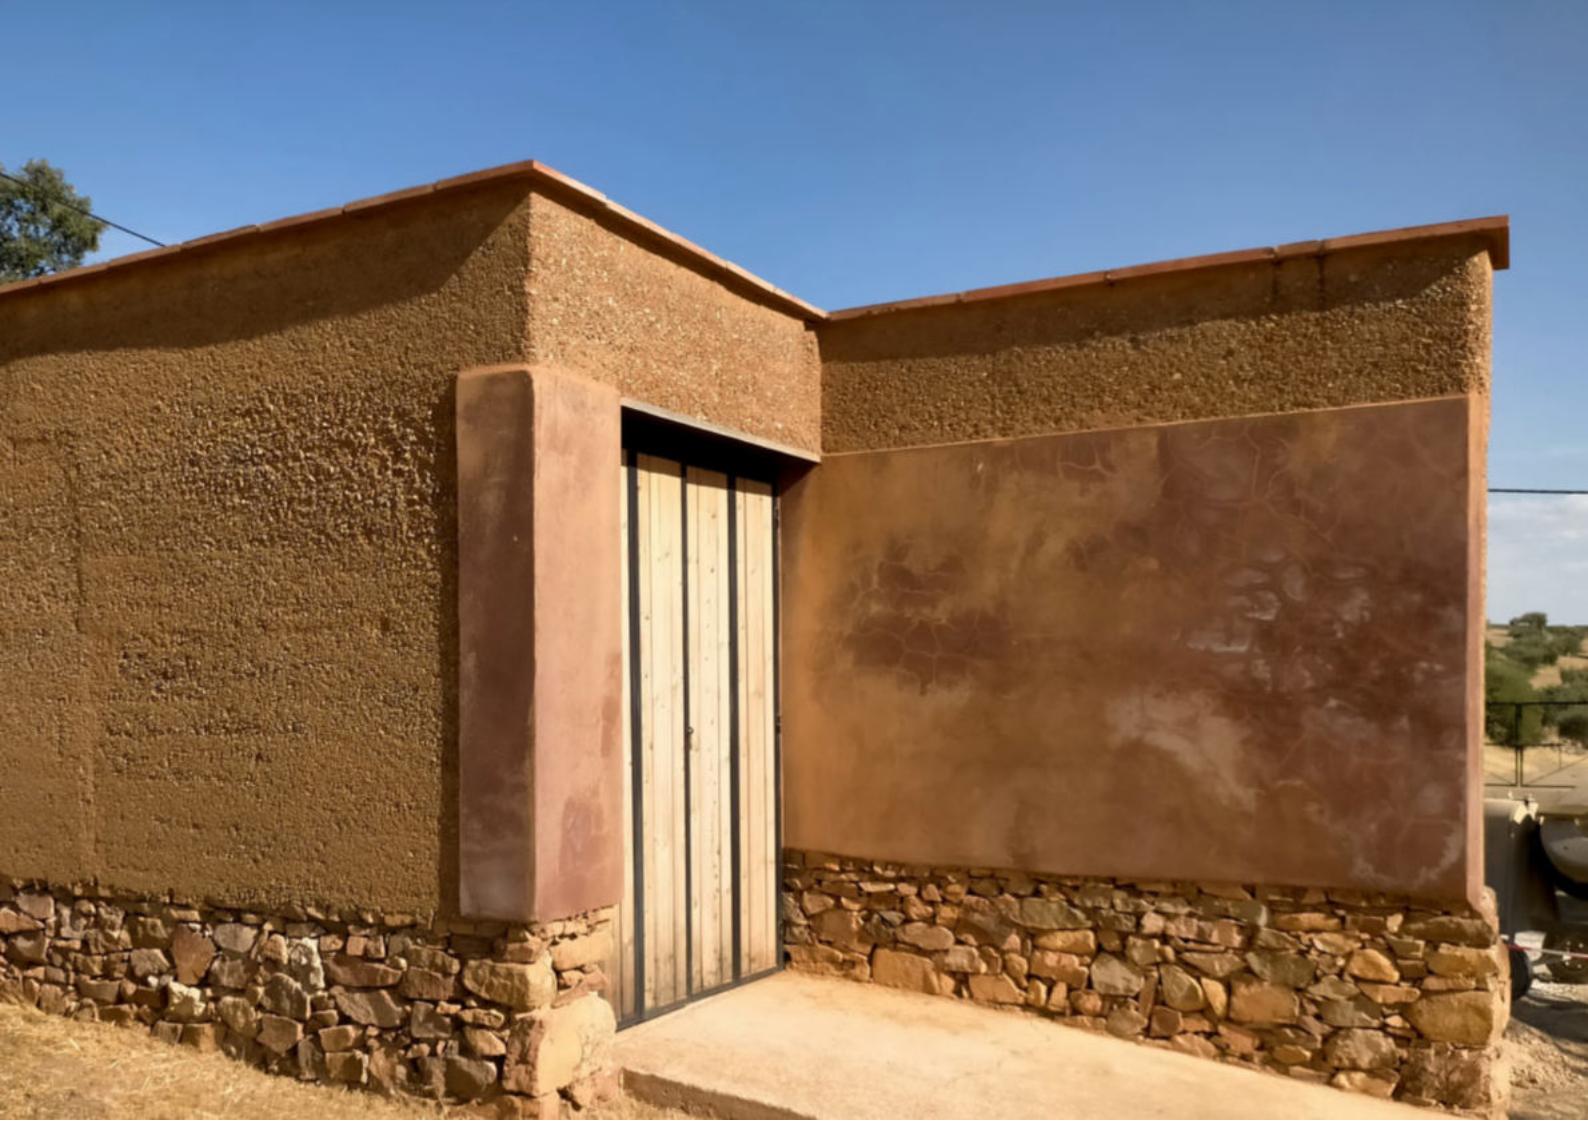
Pigmented lime plaster added after the "accident" of the water-jet, in 2018 (top) and in 2021 (bottom).

the rammed earth walls. For unknown reasons, few time after the application, the plasters get an heterogeneous aspect with thin surface cracks and whitish stains. Three years after, the aspect of the plaster is still the same, which isn't a problem for the conservation of the wall (the plaster is still hard and stable), but can be disturbing on an aesthetic point of view. There are several hypothesis to explain the pathology observed : presence of unwanted salts in the sand or in the water used for the mortar? pigment overdose? Additional research should be made to know the exact cause.

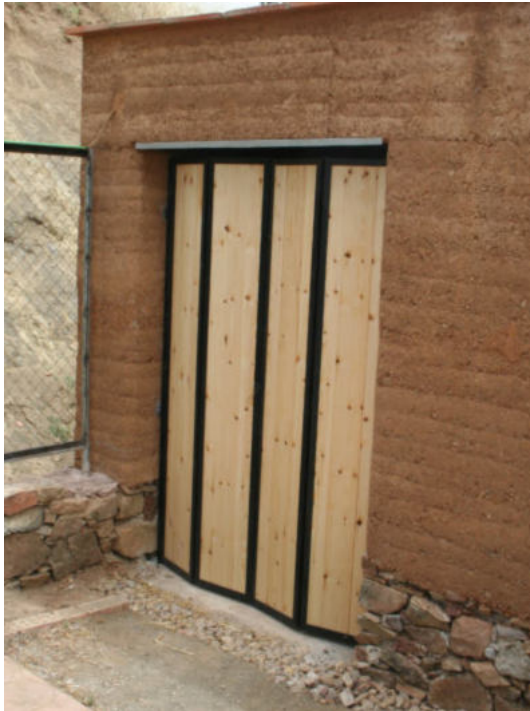
1. Door on the northern facade in 2018.

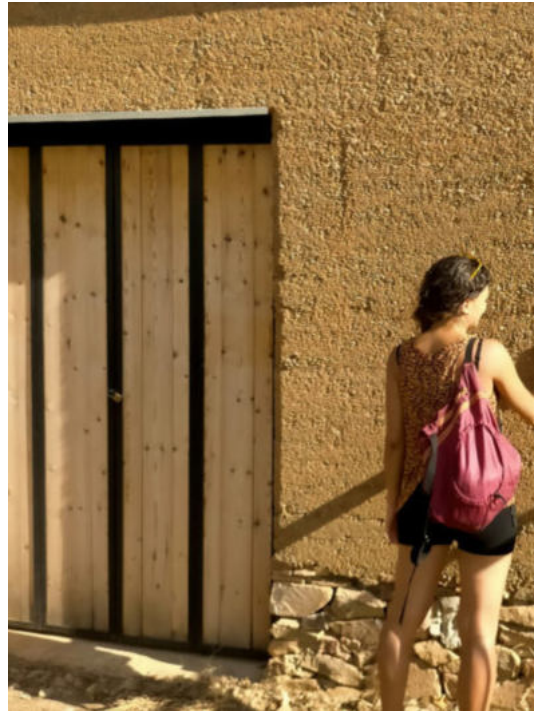
2. Same door in 2021. The bottom part of the door is starting to turn grey.

The two folding doors located on the northern and western facades were tailor-made for the project by a local artisan with steel and wood. After three years of existence of the building, they are in a perfect state and we can only appreciate a change in the colour of the wood which is turning to grey, something that was actually predicted and assumed in the design of the project as a "normal ageing" of these elements. A linen oil treatment was applied in the moment they were placed but wasn't repeated since this moment. For a good maintenance of the building, this oil should be applied every two or three years.

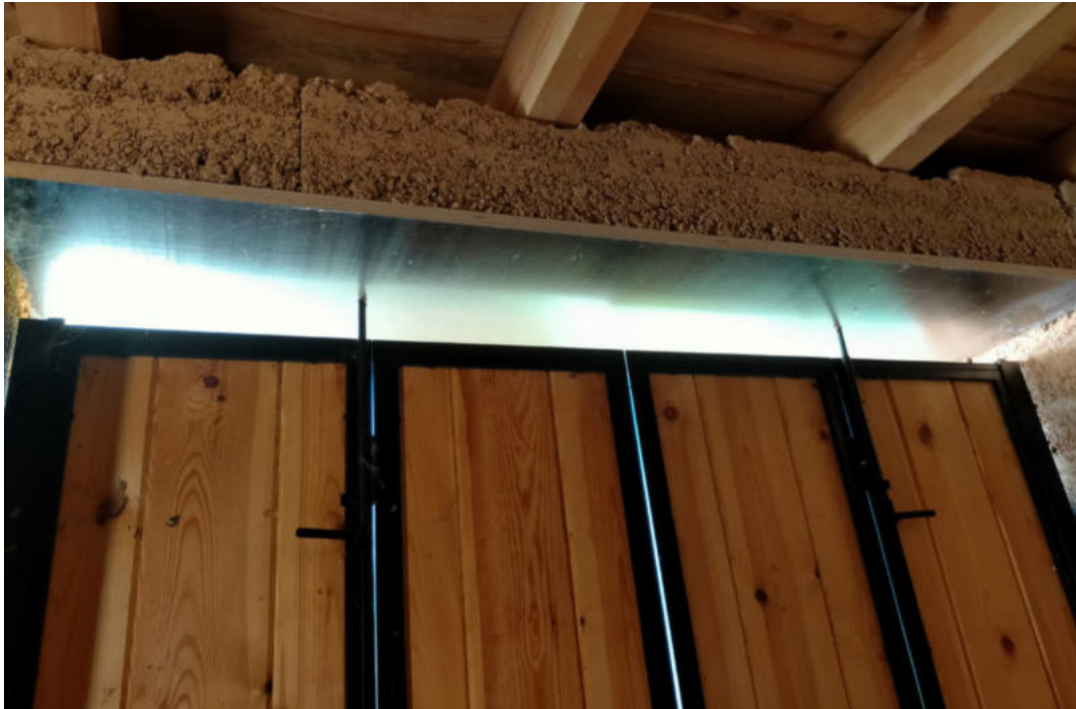
1. Gap in between the door and the wall (the building wasn't designed to be a totally closed space).

What could be improved in the design of the doors is their air tightness. Indeed, the gaps between the door and the floor, and the door and the lintel are big enough to allow dry leaves and animals to enter in the building. As mentioned before, it was intentional in the moment of the design of the building to have this air permeability of the building, because the use it would have (obviously, a library in summer time doesn't requires the

sane indoor climate conditions than a house inhabited all the year). Even if the municipality didn't expressed any inconvenience regarding this point, it's true that this could be solved in order no to have to make a deep cleaning of the library every year before the opening (while sweeping the dry leaves is easy and quick, washing the birds droppings on the walls is a bit more difficult). An easy way to fix this problem would be to place two "combs" or wooden pieces on the bottom part and top part of the doors to fill the gaps.

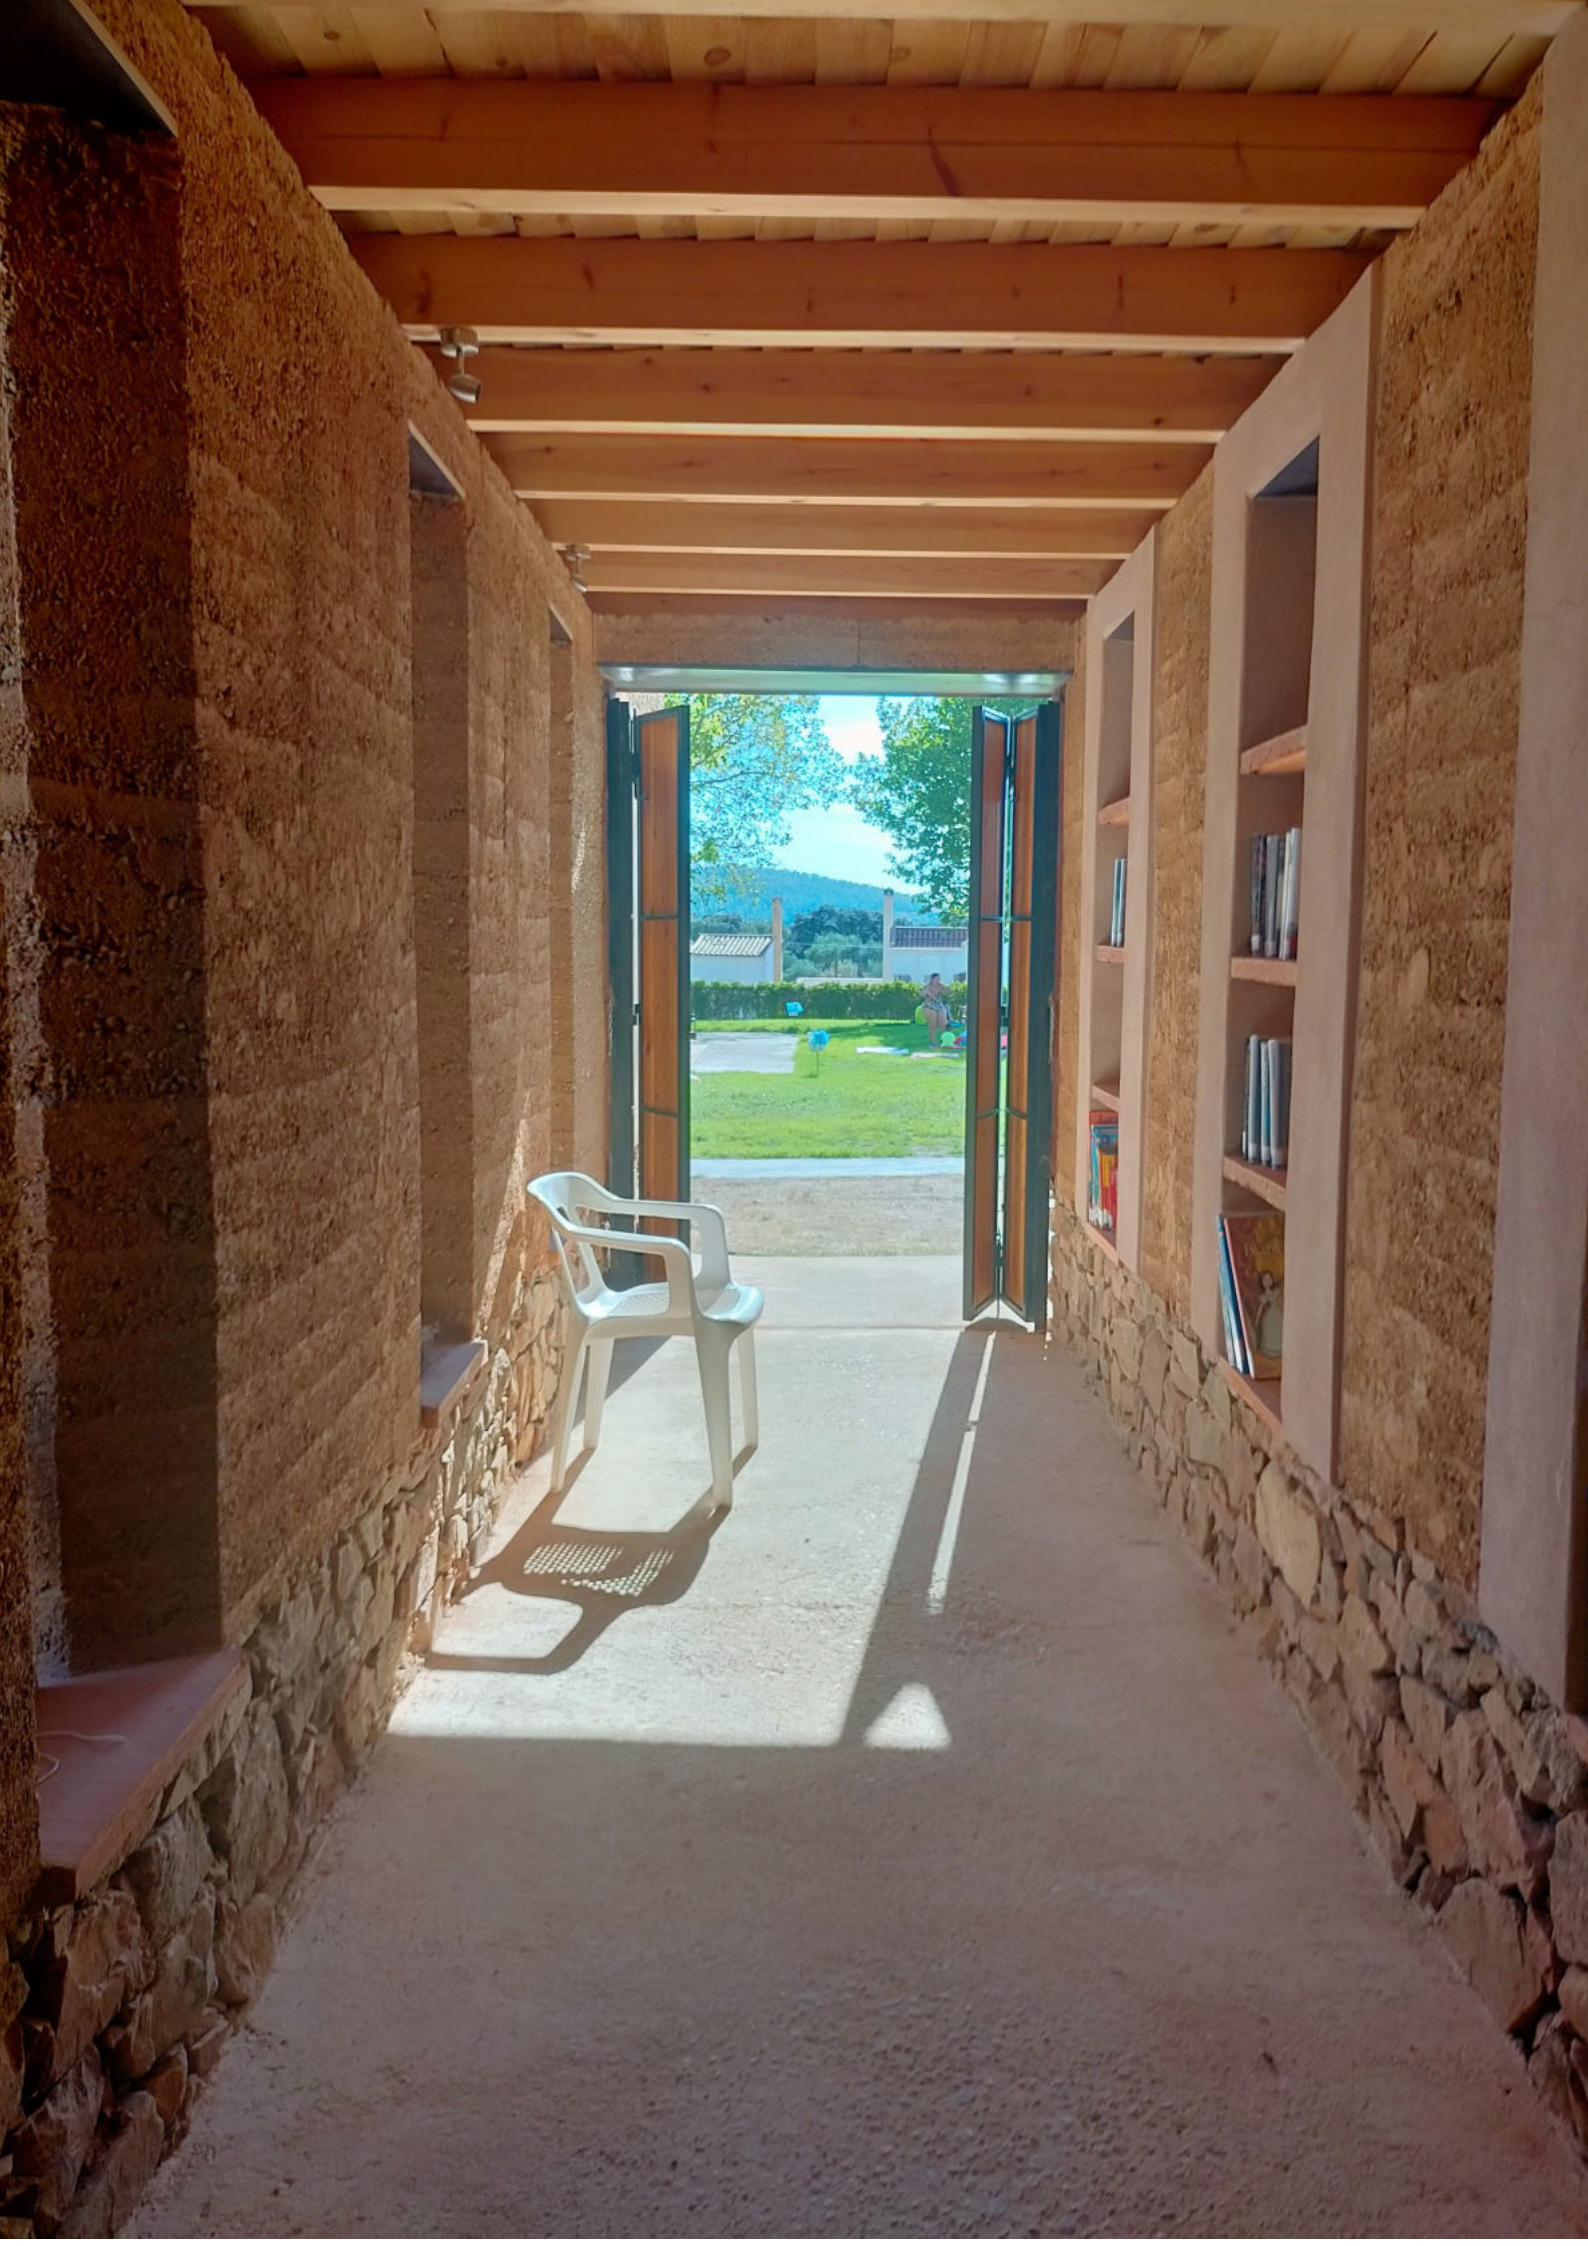
of the building of the library. In real terms, the rammed earth isn't assuming the function of a lintel on top of the windows and door (as we know rammed earth can't be submitted to flexion) but a wooden beam. The rammed earth is just behaving as a cladding of this wooden lintel, on both side of the wall (see roof detail above). The experiment clearly gave good results. Only one crack can be observed (on the wester door's lintel), but as it appears a few time after the construction, during the wall's drying phase, we can deduct it is retraction crack and not a crack due to an overload on the element.

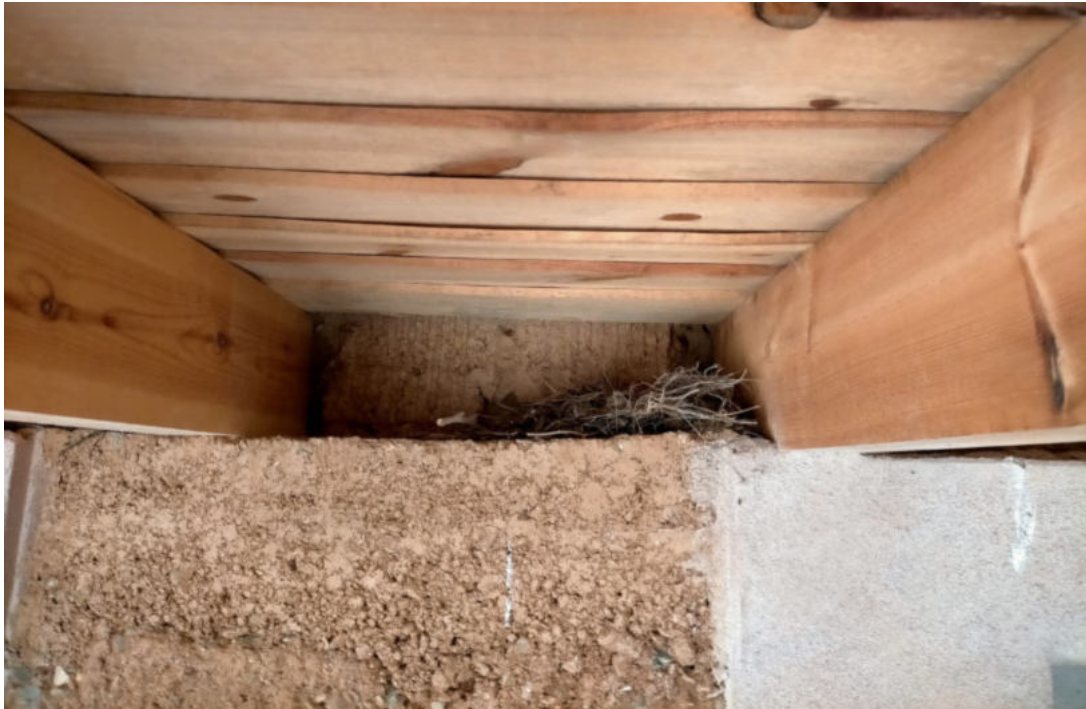
1. Nest on top of the wall in the interior of the library.

interior walls are in good general state. Touching the rammed earth walls, their texture is almost unchanged and stable. Nevertheless, we can observe on the ground and on the ceramic windows sills a small deposition of earth particles, indicating a slight erosion of the walls. Although the walls were impregnated with a stabilizing a lithium silicate solution after the construction, there is still a minor loss of mass that will probably decrease with the time.
