RAMMED EARTH

BIØN II- Follow-up report

By miga / ACTYVA

Written and edited by Lucile Couvreur, 2021

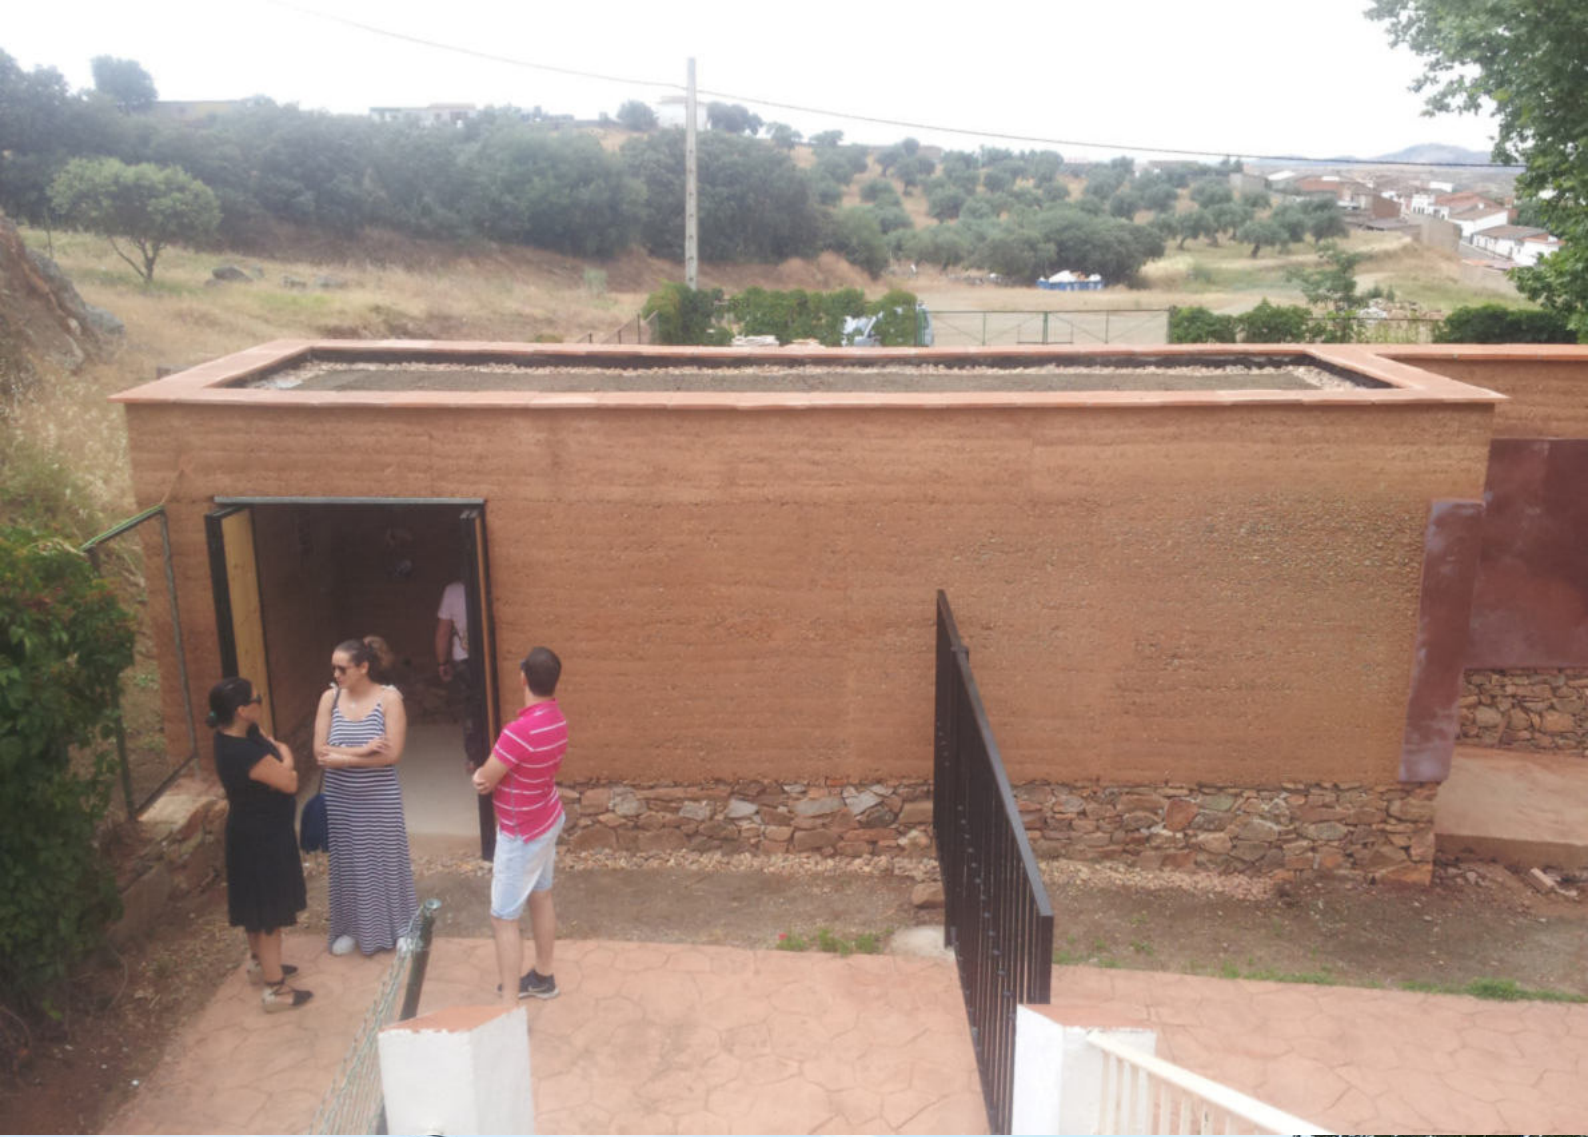
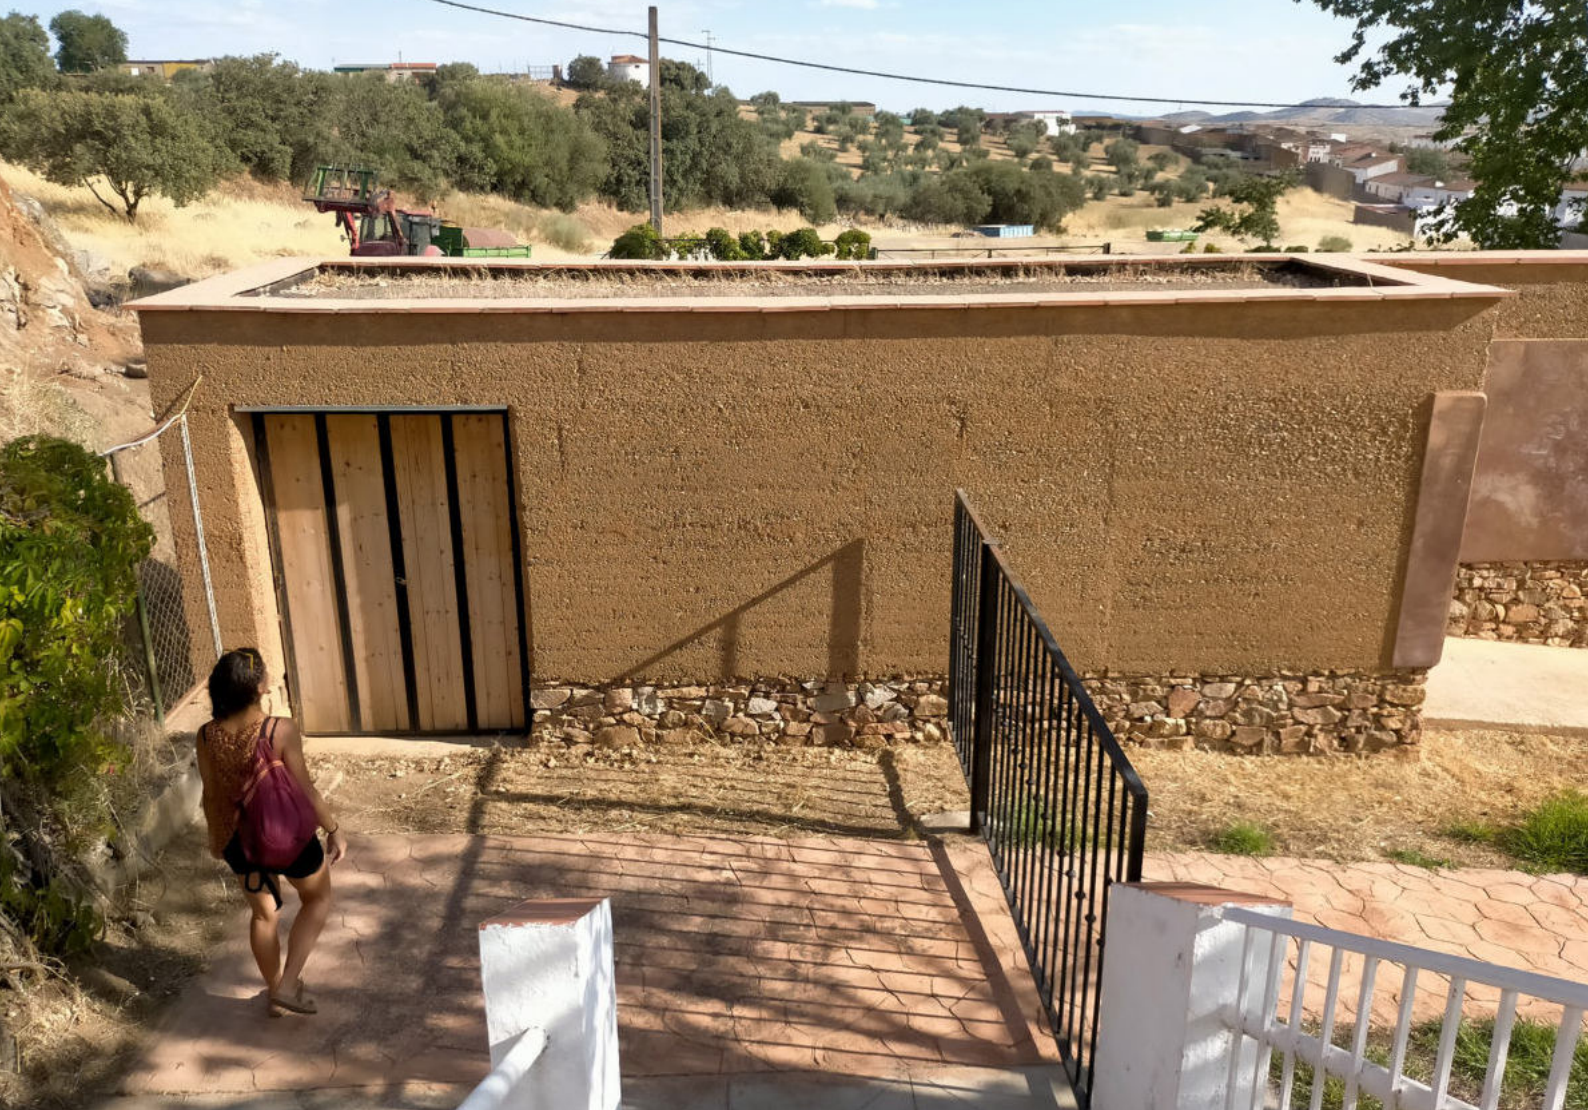
View of the northern facade in 2018 (top) and 2021 (bottom).

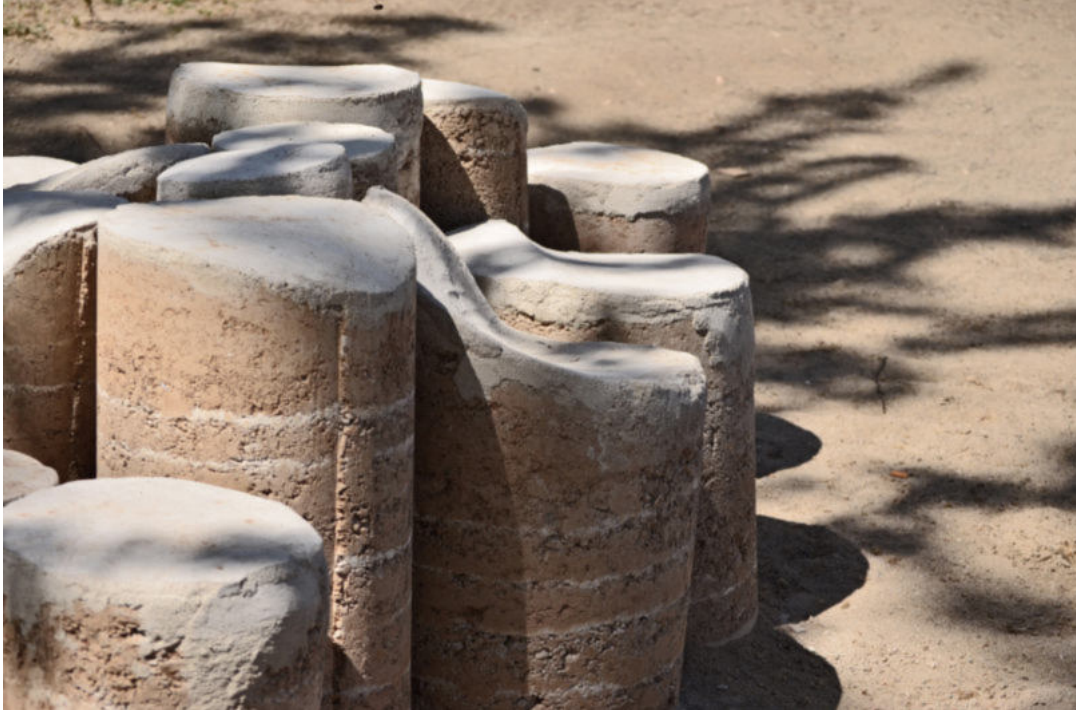
1. Furnitures made by Ak0 during the workshop.

Regarding the rammed earth furnitures (reading space) built by the partner Ak0 during the workshop to experiment with the prefabrication techniques, three years after the construction there is no trail of it. Unfortunately, the elements didn't resist to the first rains and had to be removed from

the site few time after the workshop. A higher basement and maybe some more stabilization is required to keep this kind of rammed earth elements exposed to weathering.
